# DESCRIPTION OF LOWER HULL INDENTATION DAMAGE 1 ON THE WRECK OF HMS *PRINCE OF WALES* (P1 – 20)

**ALL VIDEO IMAGES WERE TAKEN DURING EXPEDITION 'JOB 74'  
IN MAY 2007, AND THIS REPORT COMPILED BY Kevin Denlay**

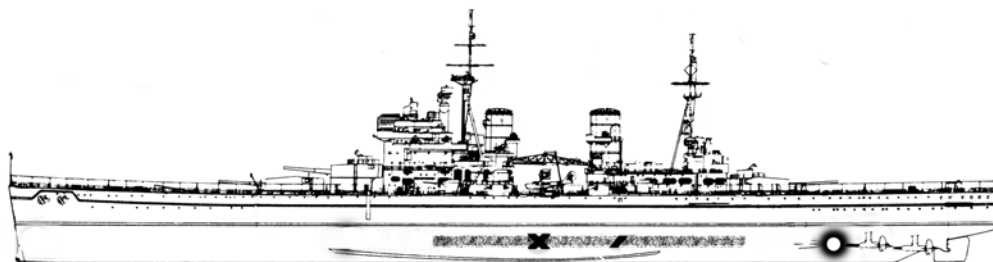
**PORT HULL**

The above diagram shows the *port* side of Prince of Wales. The shaded area on the hull is the area the indentation covers, which is **approximately 70m/230ft** in length.

The position above marked with an 'X' is where it is deepest (that is, where hull is pushed *inwards* the most from the bottom edge of the amour belt) and there is *some* crumpling of the hull here, but no 'penetration' as it were. The position marked with a slash '/' is also where there is some *slight* crumpling of the hull, but again, no penetration.

If you can envision the shape of the indentation (see schematic and illustration on page 4), it 'bows in' from well forward of the X to be widest/deepest at point X before gradually blending back into the normal hull shape about *halfway* between bilge keel end and where outer prop shaft exits the hull at the stern tube gland.

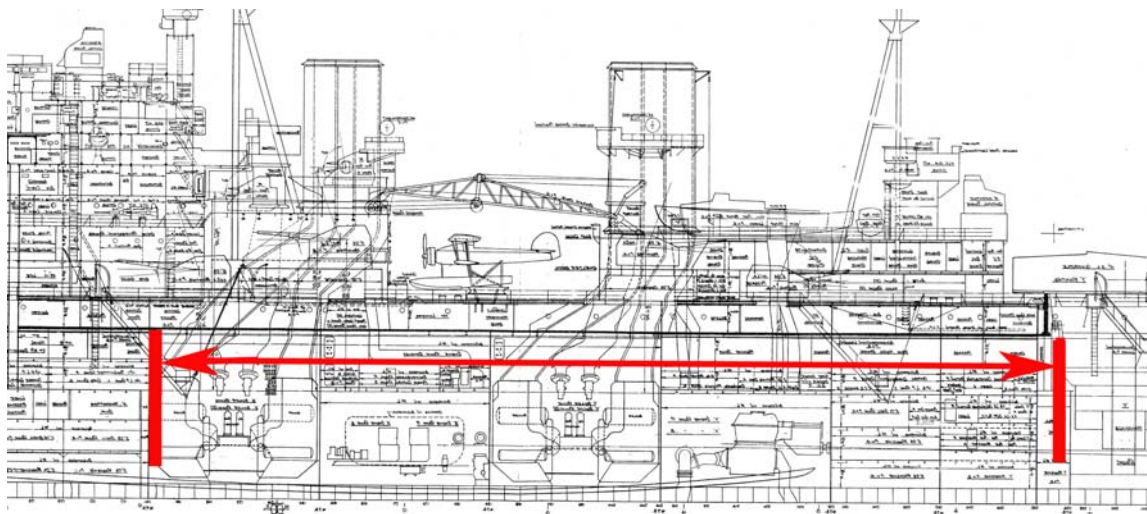
**PLEASE NOTE:** This is a *starboard* hull plan that has been '*flipped*', or rotated horizontally, as *port side* plans were unavailable, and the port hull indentation coverage area marked on it; so text will be unintelligible if enlarged onscreen. (Also note: Red arrow is drawn higher than where the actual indentation is, so if this document is enlarged the compartments inboard of where the indention is can still be discerned.) The port indentation therefore extends the length of the red arrow, from approximately Frame 140 forward to approximately Frame 255 aft; approximately 70m / 230ft in length overall. It is of note that the Side Protection System (or the internal 'sandwich' protective layers) extends from Frame 79 forward to Frame 253 aft, so basically the entire length of the indentation is along an area covered by the SPS.

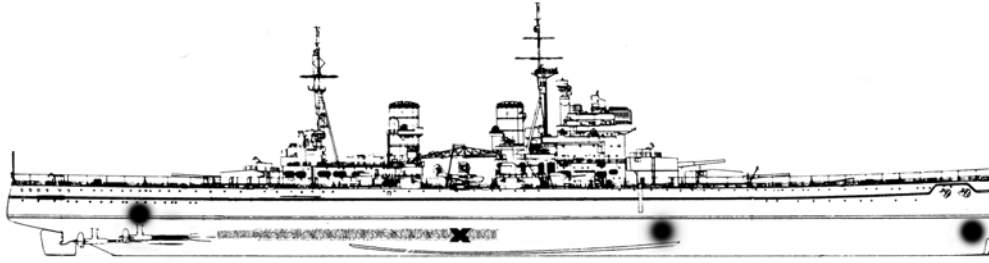
## STARBOARD HULL

The above diagram shows the *starboard* side of Prince of Wales. The shaded area on the hull is the area the indentation covers, which is **approximately 65m/213ft** in length. *Pages 6 through 20 show images (from video) of this starboard side indentation.*

The position above marked with an 'X' is where it is deepest (that is, pushed inwards the most from the bottom edge of amour belt) and there is *notable* crumpling of the hull on the forward side (of the X) here, but no penetration.

If you can envision the shape of the indentation (see schematic and illustration on next page), it starts just forward of the X and bows in *immediately* to the X, which is basically the widest/deepest point, and then remains almost as wide for some distance (to past the end of the bilge keel) before gradually blending back into the normal hull shape at about where the outer prop shaft exits the hull at the stern tube gland.

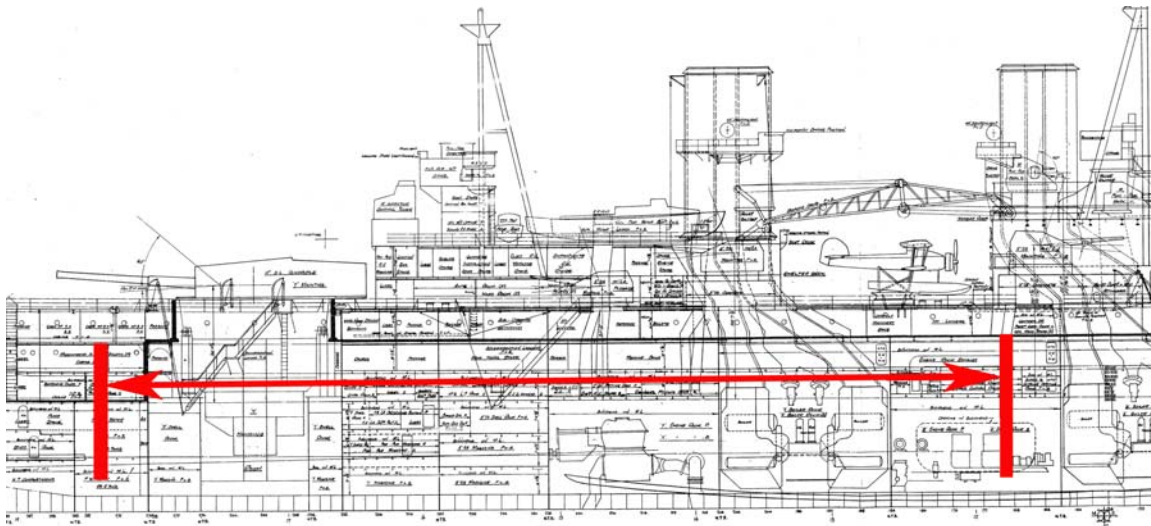
**Note:** The red arrow is drawn higher than where the actual indentation is, so if this document is enlarged on screen the compartments and text inboard of where the indention actually is can still clearly be discerned

The starboard indentation extends the length of the red arrow, from approximately Frame 170 forward to approximately Frame 282 aft; approximately 65m / 213ft in length overall. *It is of note that the Side Protection System (or the internal 'sandwich' protective layers) extends from Frame 79 forward to Frame 253 aft, so three quarters of the length of the indentation is along an area covered by the SPS. Only from Frame 253 to Frame 282 is outside the SPS, but it is not the most indented or seriously damaged area anyway.*

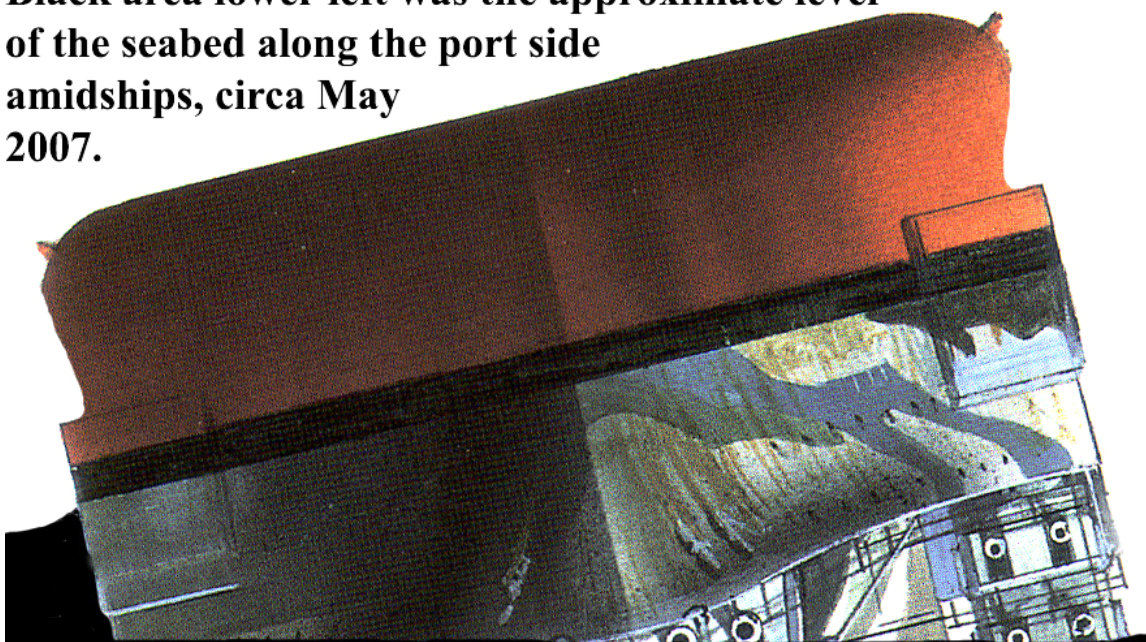
The wreck rests upside down at an angle to port of about 15° *amidships*. The indentations previously described on either hull just below the armour belt are shaped as seen here.

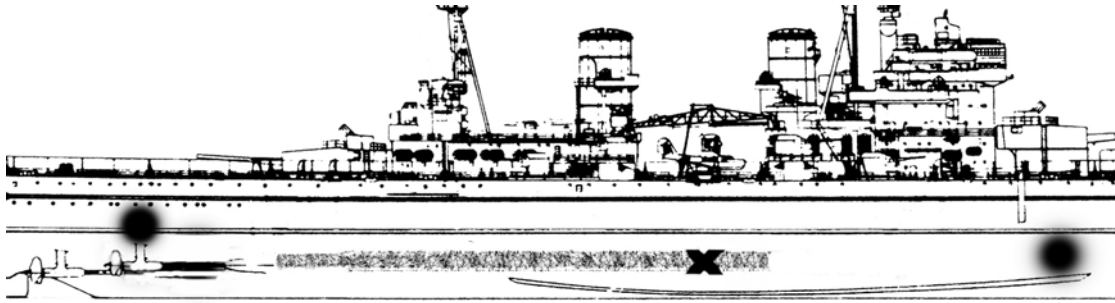
### STARBOARD HULL

The shaded area on the hull marks the extent of the deformation / indentation along the **starboard** hull and is **approximately 65m/213ft in length**. The black dots are where two of the three torpedoes hit on this side. (Note the height of the aft hit, which gives an indication of just how far the aft section had submerged in the forty odd minutes since the first hit aft on the port hull.) The 'X' marks where the indentation is the deepest, however it continues aft almost as deeply indented past where the bilge keel ends, before gradually reducing to 'a normal shaped hull' where the outer prop shaft exits the hull at the stern tube gland. **(The port side hull deformation is almost identical but covers a slightly different area,** as shown on the drawing and schematic on page 2; *however no images of the port side indentation are shown in this report, as the 'lighting' of the video footage was too poor to 'pull' still images from.*) On both hulls the indentation 'begins', vertically as it were, at the *bottom* edge, or base, of the armour belt – as seen in the schematic on page 4 - where the hull plates have actually been 'sprung' at the seams.

The following statistics are of note when looking at what might *appear* to be relatively minor damage (i.e. seams split along riveted plates), if compared in context to the much larger torpedo holes. However, a small hole below the water line will let in a large amount of water. *For instance, if you have a 2.5cm (1") hole, 10 meters (33ft) below the water line that hole will let in just over 437 liters (115 US gallons) of water per minute.* If you then have 10 sprung riveted hull plates each the equivalent of only a 2.5cm (1") hole, that is 4370lts (1,150 US gals) per minute, or 4370kg (9634 lbs) / 4.37 tonnes (4.3 tons) of water per minute. A hundred such hull 'holes' equals 43.7 tonnes (43 tons) per minute; *or 2622 tonnes (2580 tons) per hour!*

As stated previously, the Side Protection System extends from Frame 79 forward to Frame 253 aft; so only from Frame 253 to Frame 282 is outside the area covered by the starboard SPS - and not as extensively damaged (while only two frames are 'outside' port SPS). What effect then did these extended hull deformations / split seams over the SPS have on, or contribute to, the overall flooding? We know the starboard side SPS had been intentionally counter-flooded early in the action, to help counteract the 11.5° list to port, but the effect of the port SPS flooding is somewhat of an unknown factor. The severity of its flooding (in relation to other compartments) would depend entirely on the extent of the damage to the internal sandwich layers of the SPS, but what of the effect on the stability of the ship; especially if the port SPS flooded late in the action from the near miss bombs.

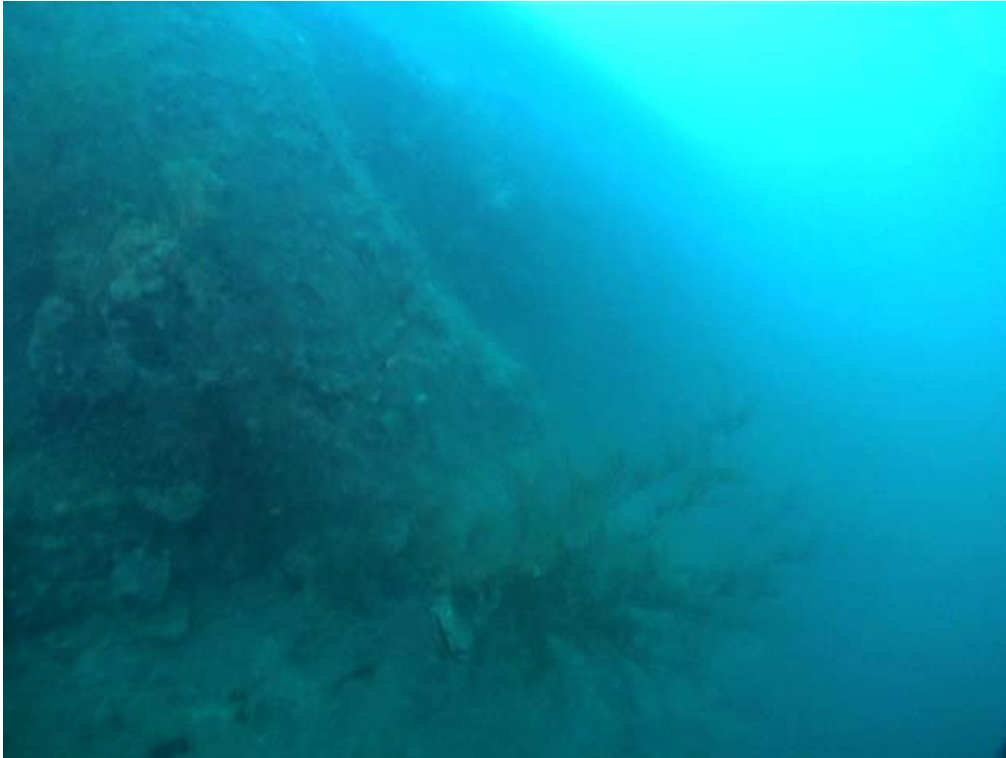
Looking aft along Starboard hull from, approximately, beneath the forefunnel. Note crumpling of the lower hull between armour belt and bilge keel in upper half of image.

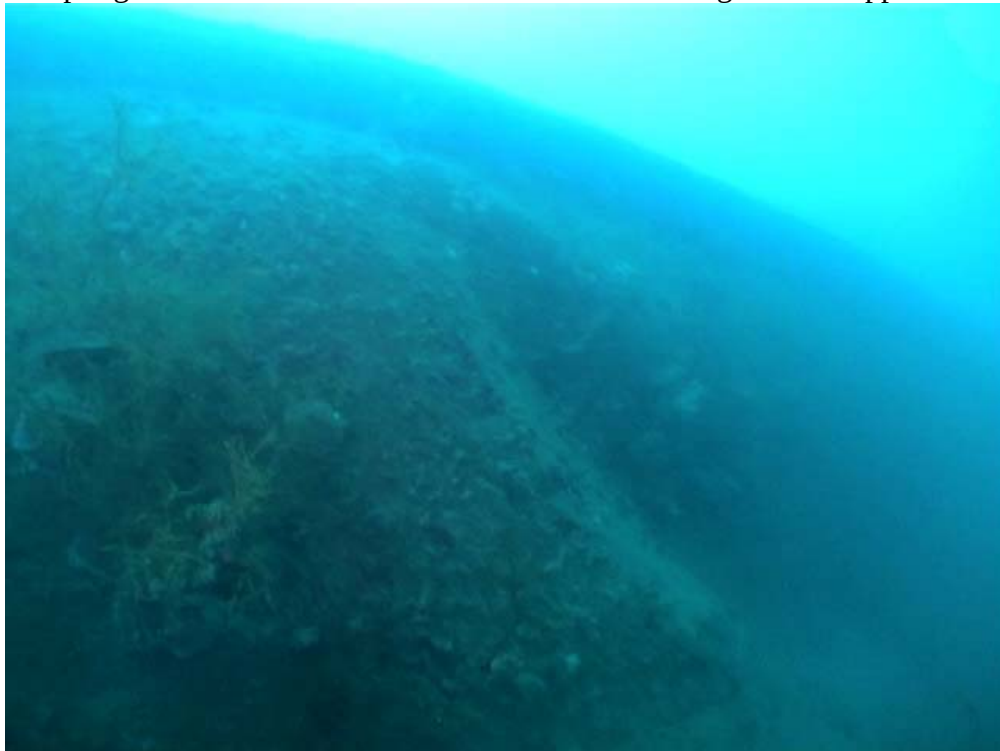
Looking 'in' at the forward edge of the crumpling of the Lower Hull. The Starboard Bilge Keel can be seen traversing across top from upper left corner. The bottom of the Armour Belt is just *outside* the bottom of the image.

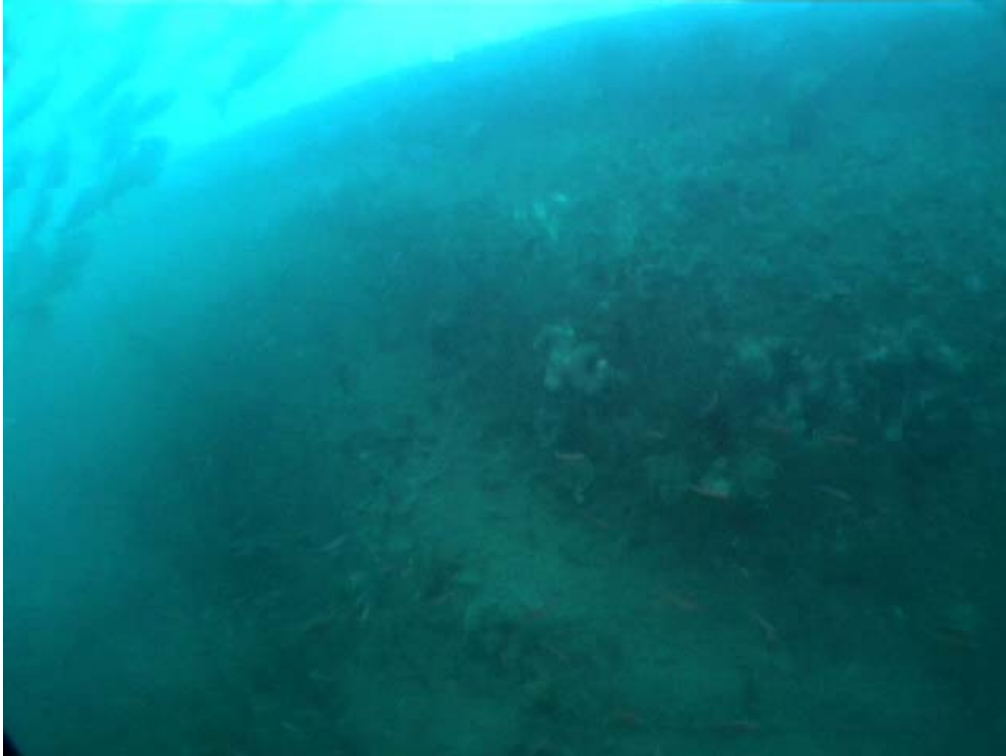
Looking forward at the crumple in the hull. The Starboard Bilge Keel can be seen across top from upper right corner. Again, the Armour Belt is just *outside* bottom edge of image.

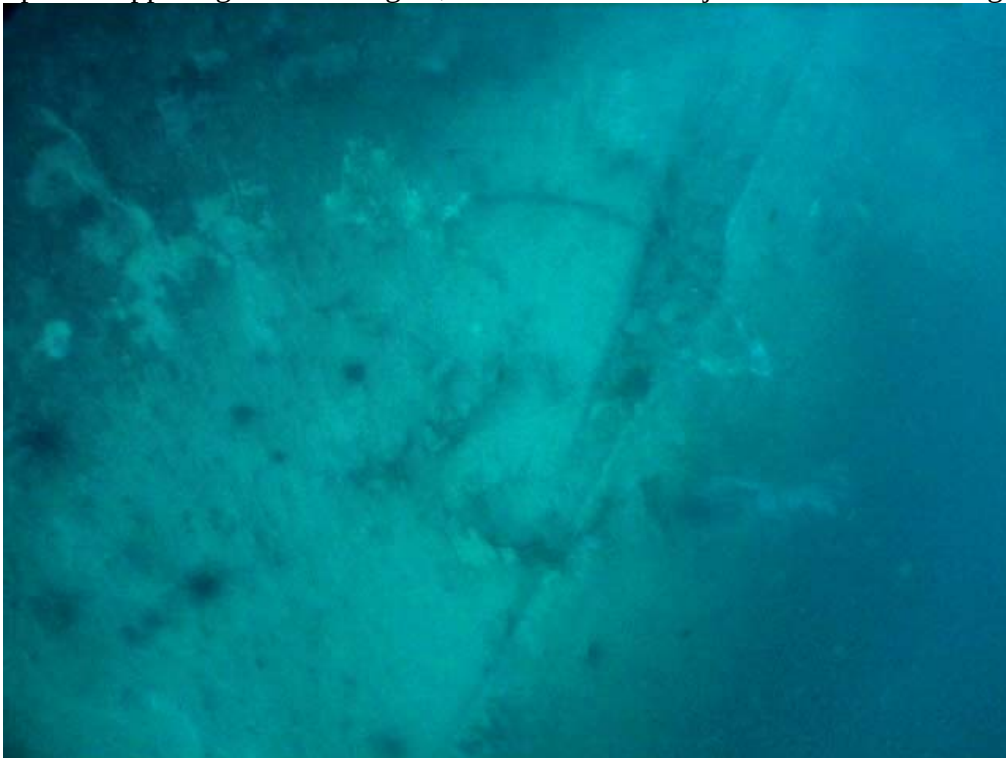
Looking 'down' and aft from the same position as above. The beginning of where the Hull Plate begins cracking away from the base of the Armour Belt can be seen. Bottom of Armour Belt is at right and Lower Hull is indented in to the left.

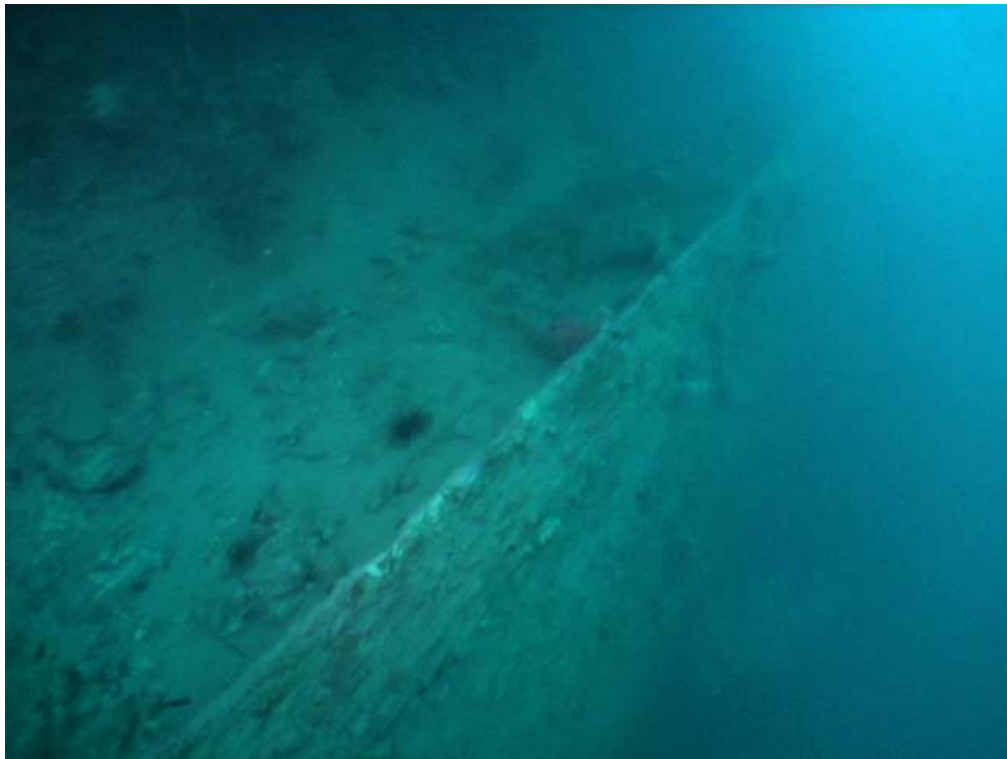
Continuing aft the indentation or 'step' immediately gets noticeably wider.

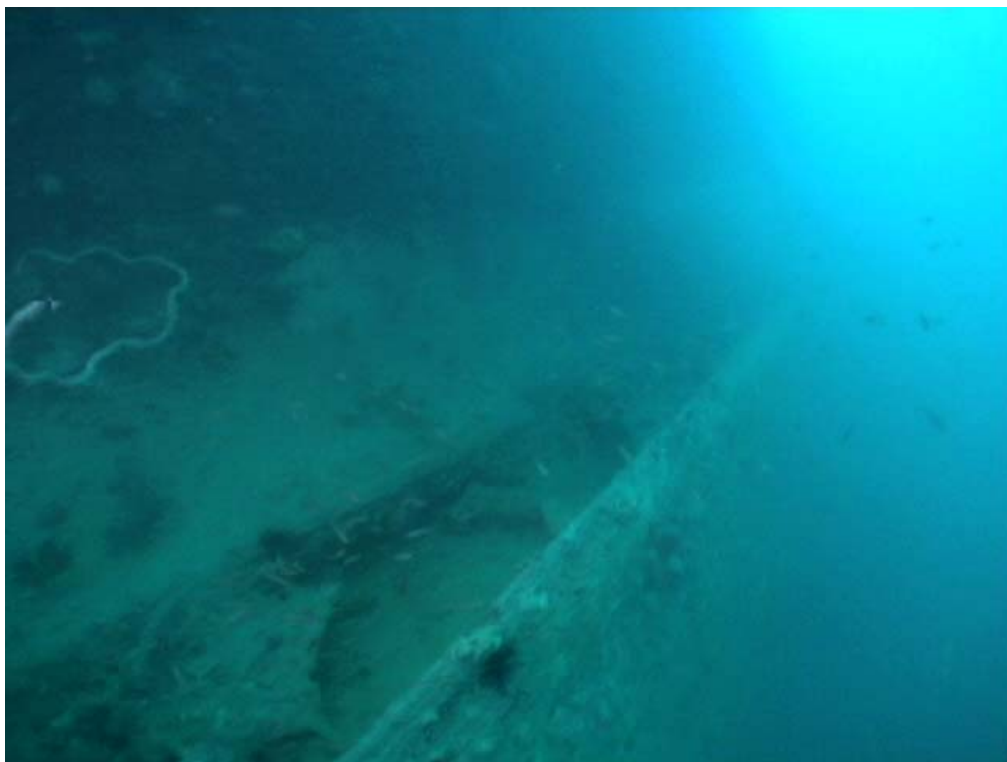
A split can now be seen to have developed under the Hull Plate (left) where it has pulled away from the Armour Belt (right).

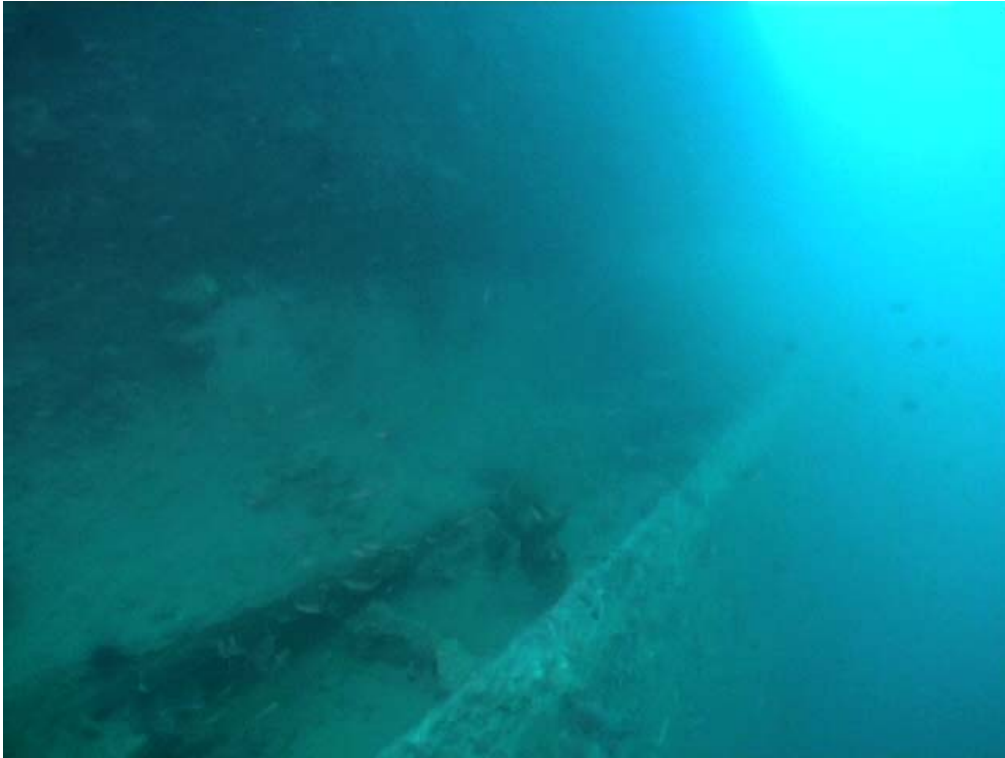
The split continues (from lower left corner) and one starts to get a better idea of how far in the hull is indented. (Left and above is Lower Hull Plate, lower right is Armour Belt.)

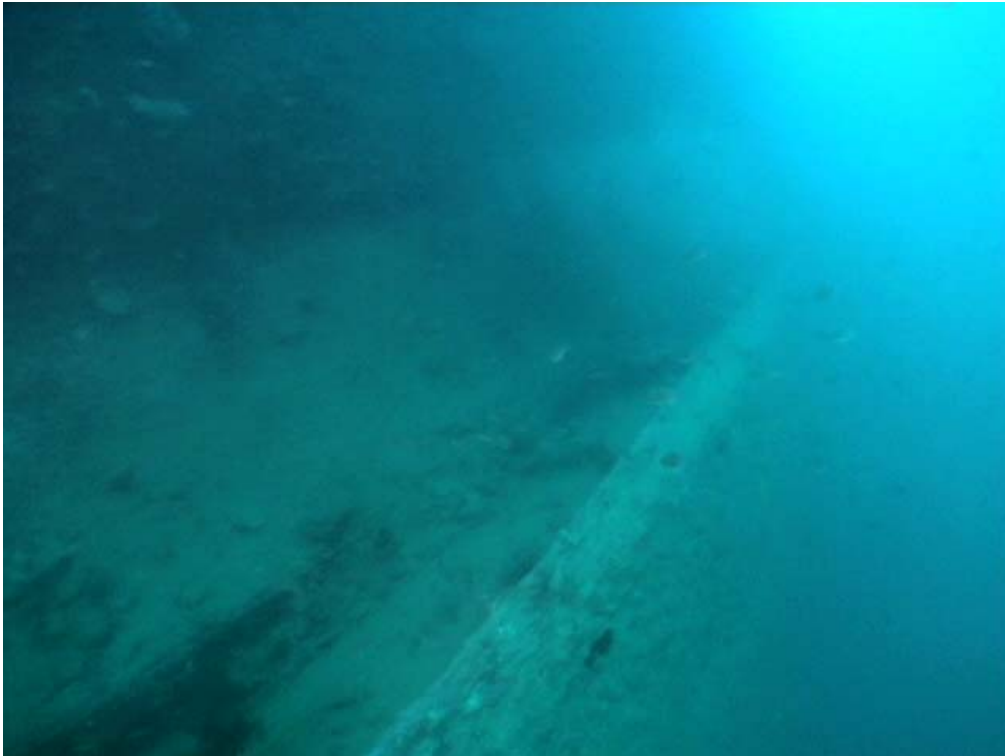
The split under the Hull Plate gradually 'closes up', temporally. The location of this image is approximately below the aft edge of the *rear* Funnel.

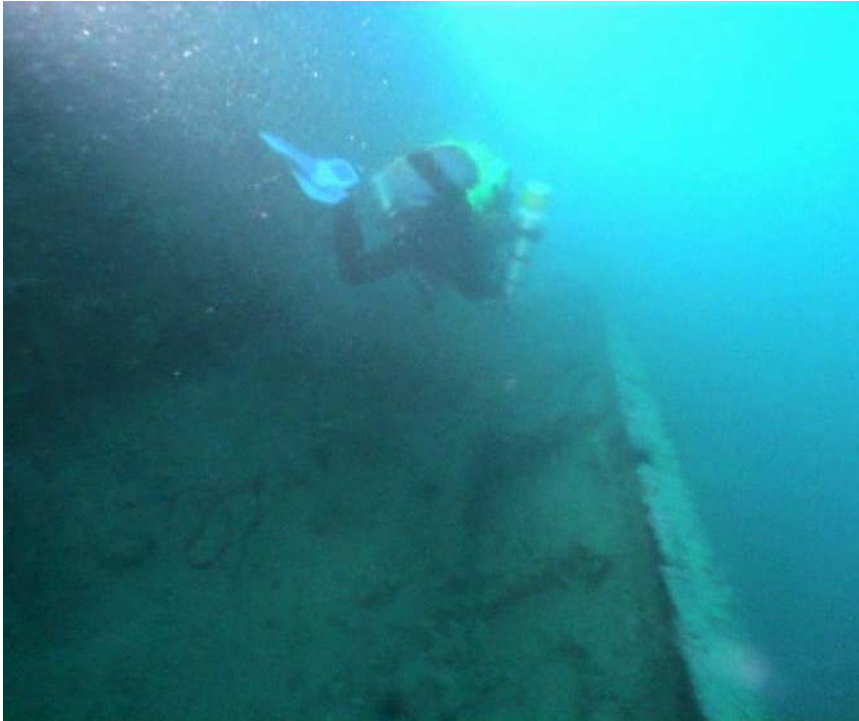
To get an idea of scale, a diver can be seen swimming along the 'step' in the exact same location as the previous photo, showing just how wide the 'step' or indentation is. Lower or 'bottom' edge of Armour Belt can be clearly seen at right.

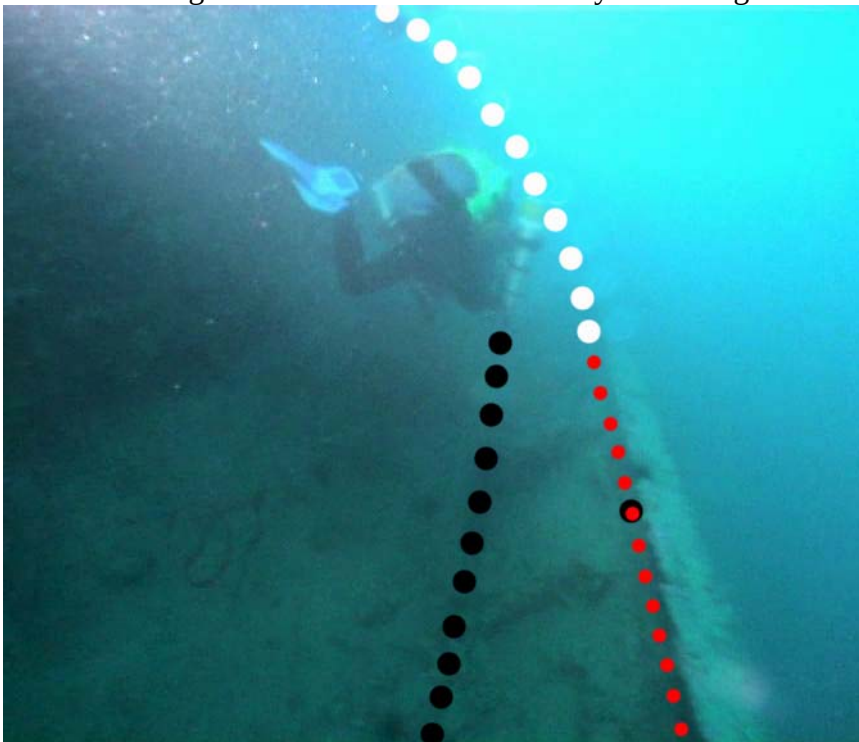
Dotted **white line** is the convex shape the Lower Hull side curve should actually take, but Lower Hull is now concave (left); while the longitudinal edge of the Lower Hull Plate shown by the **black dots** should actually join to the **red dots** (which is the base of the Armour Belt).

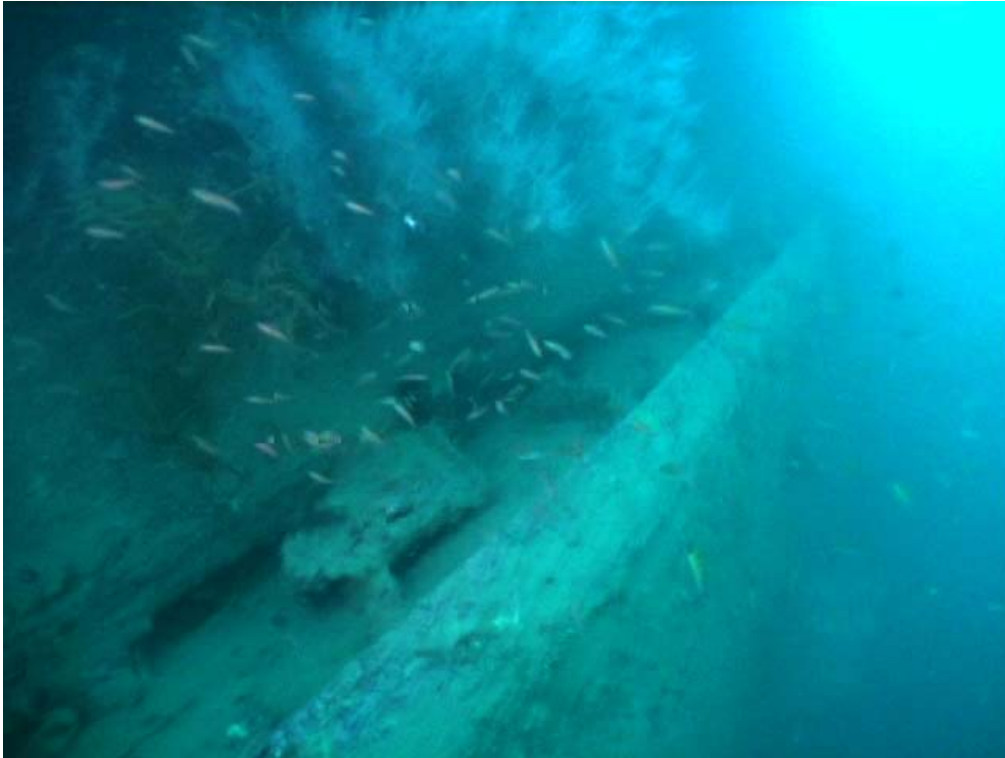
Slightly further aft, but still forward of where the Starboard Bilge Keel ends. Note that the split under the Hull Plate has again become prominent.

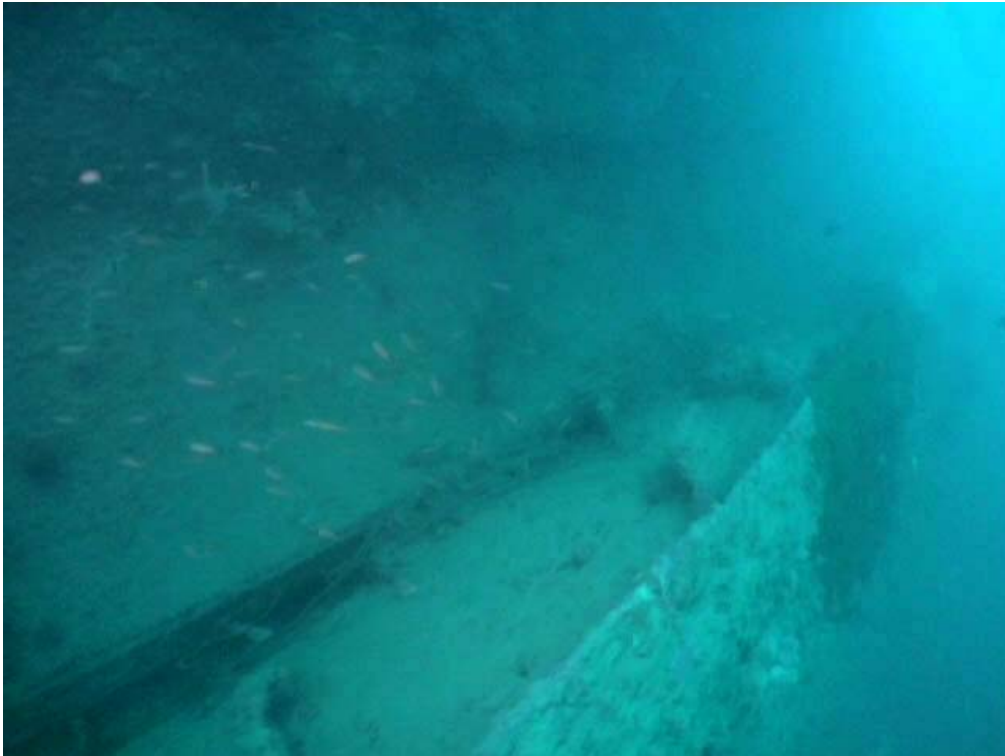
The split continues, but is gradually starting to 'close up'.

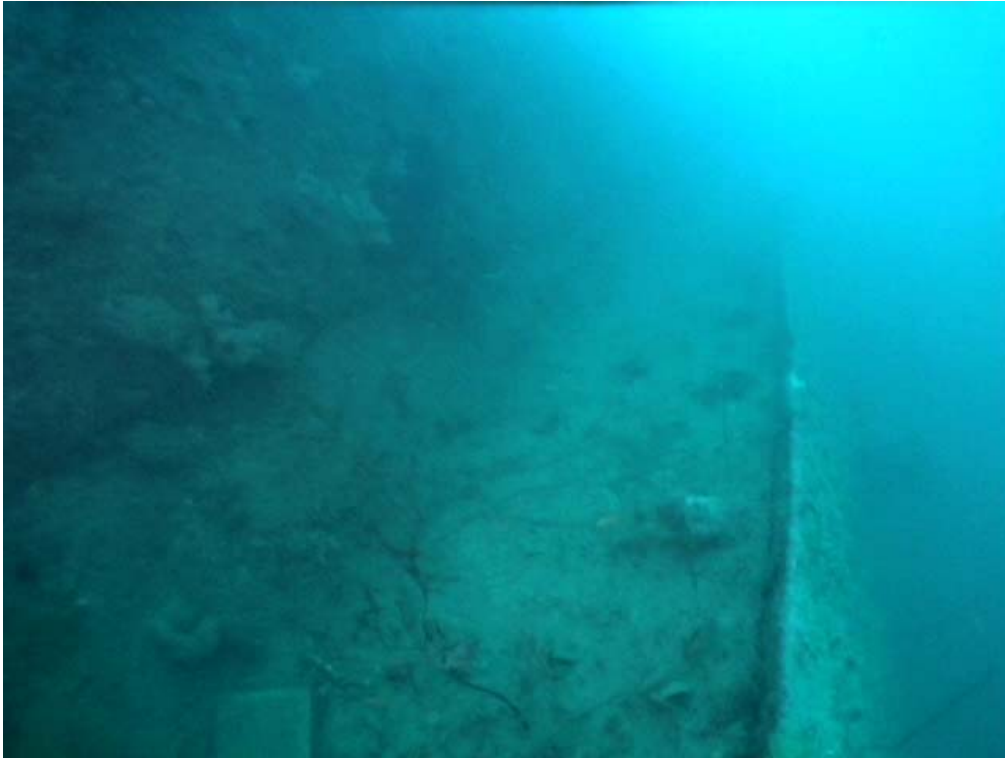
The split has 'closed' but the wide 'step', or indentation, still remains.

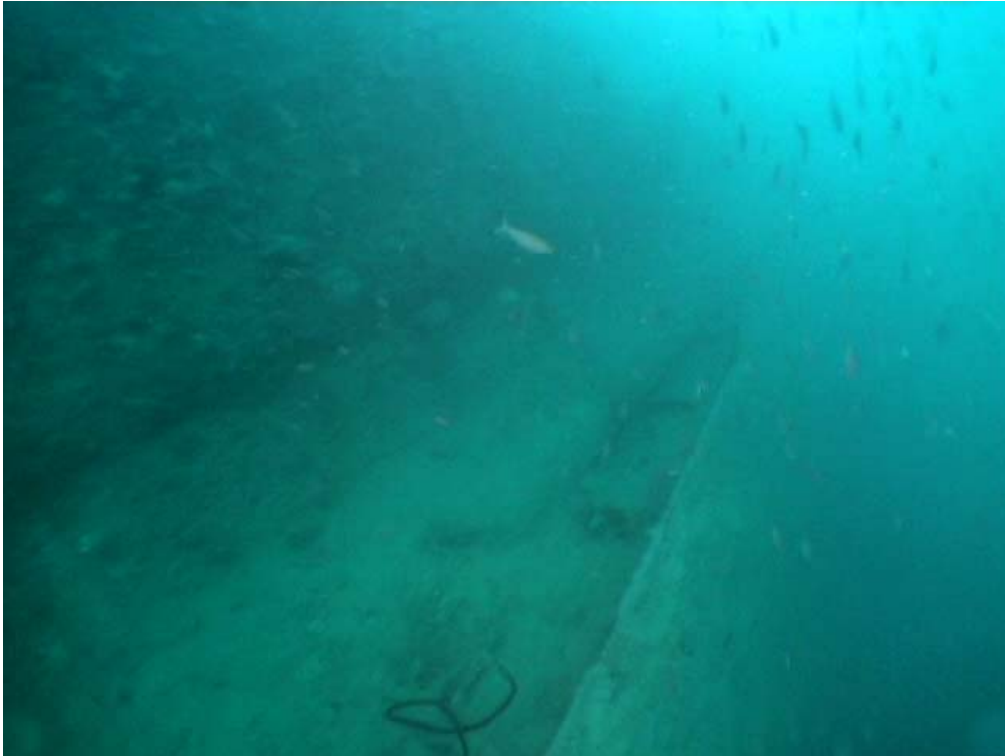
Continuing further aft the split begins to open up again, seen here in middle distance.

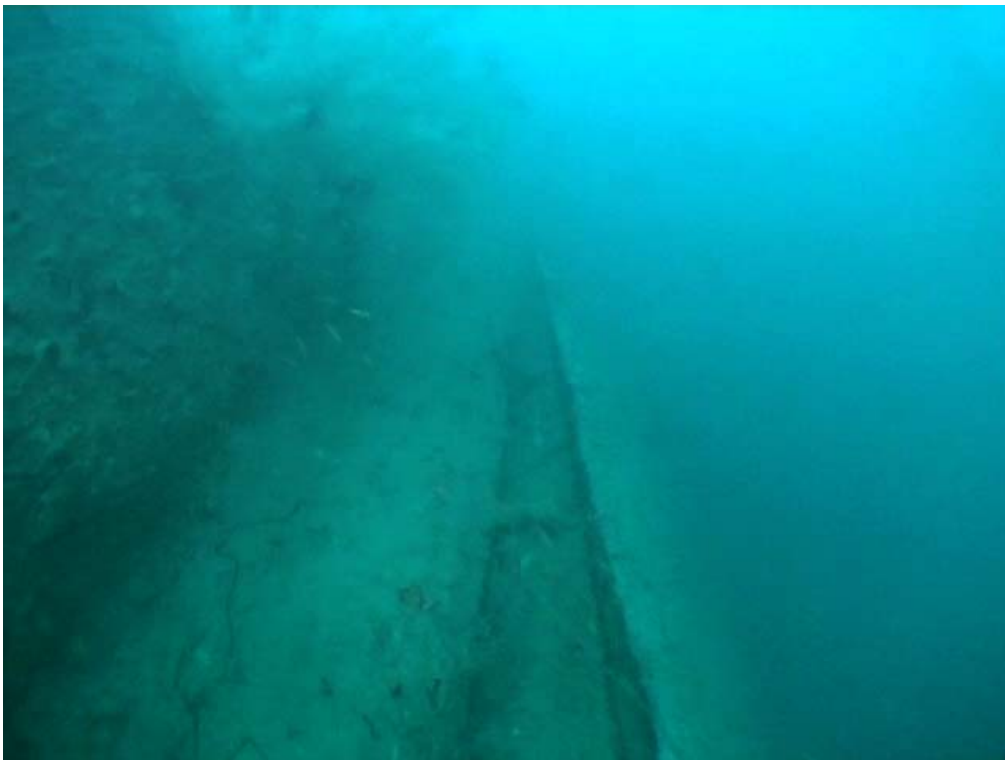
The split has opened up again slightly, but not as much as further forward. Step / indentation however is still quite wide.

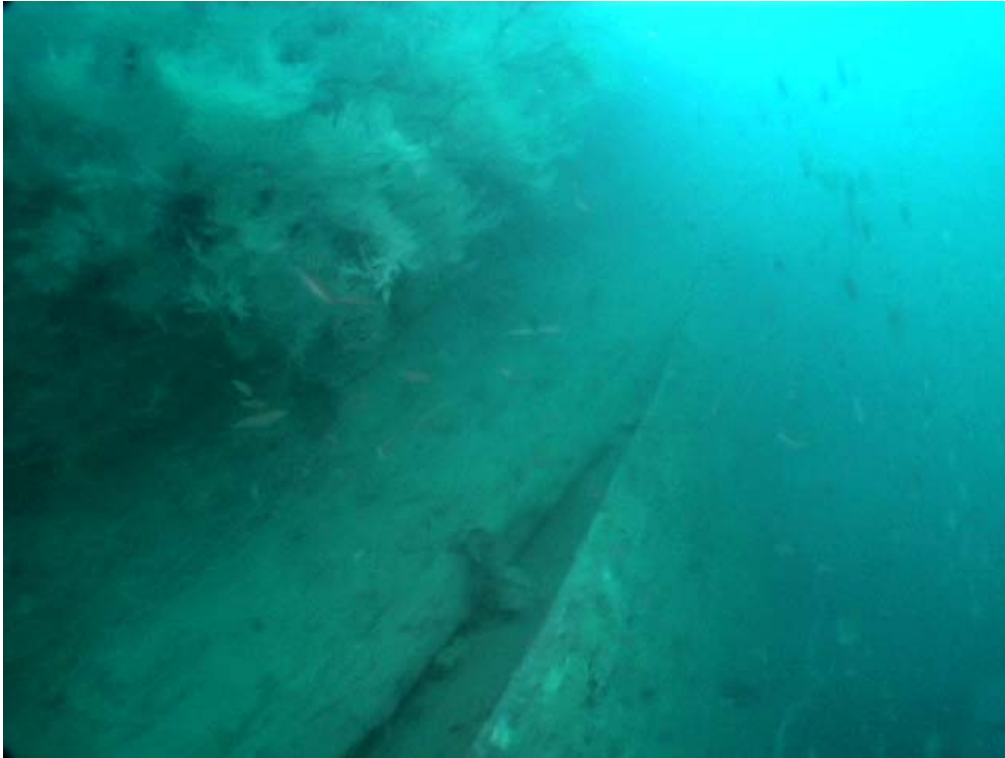
Split gradually closes up again and step / indentation begins to lessen slightly.

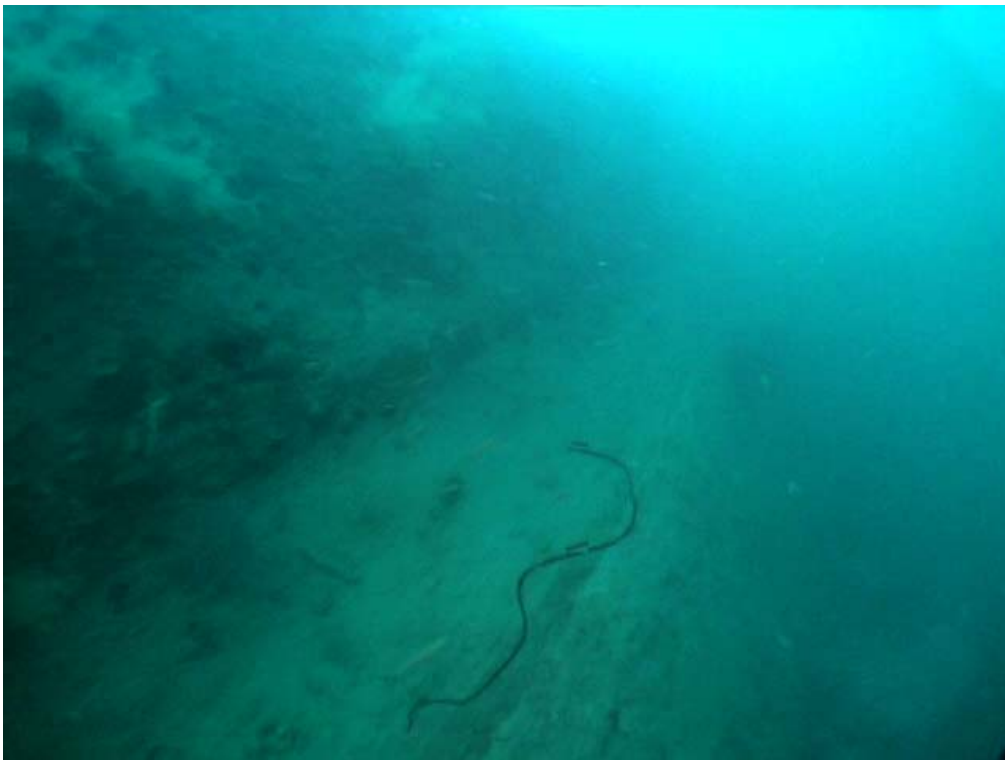
Split has almost closed up and indentation is gradually getting narrower (as shown over next several images).

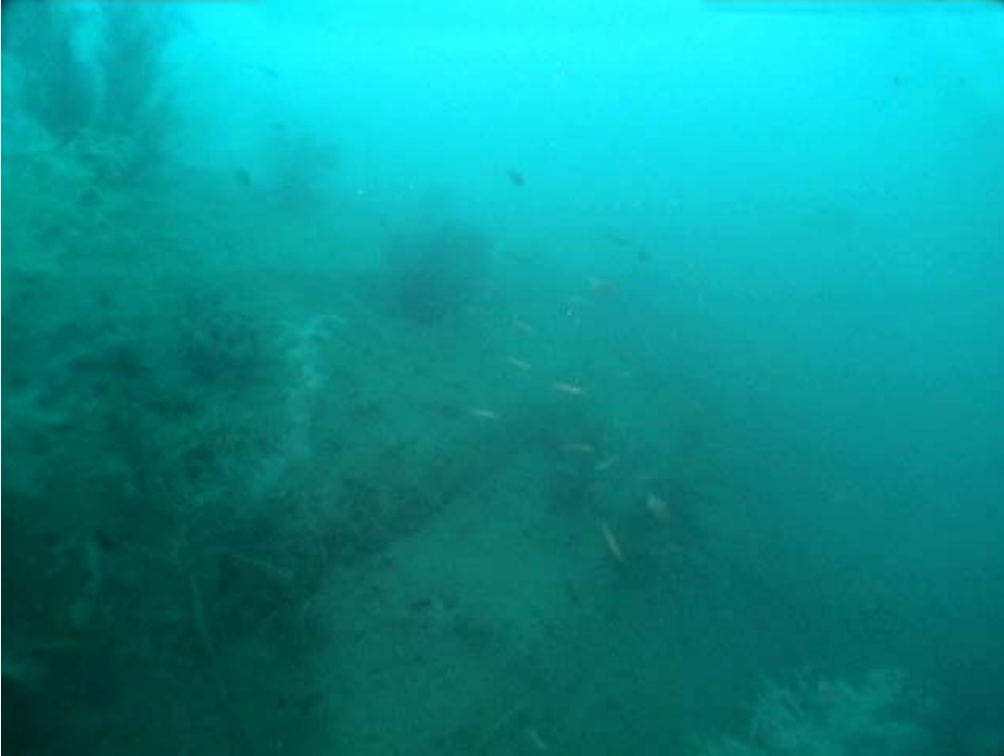
Slightly further aft, just forward of where outer propeller shaft exits the hull at the gland. The step or indentation has now *almost* blended back into the normal shape of the hull.

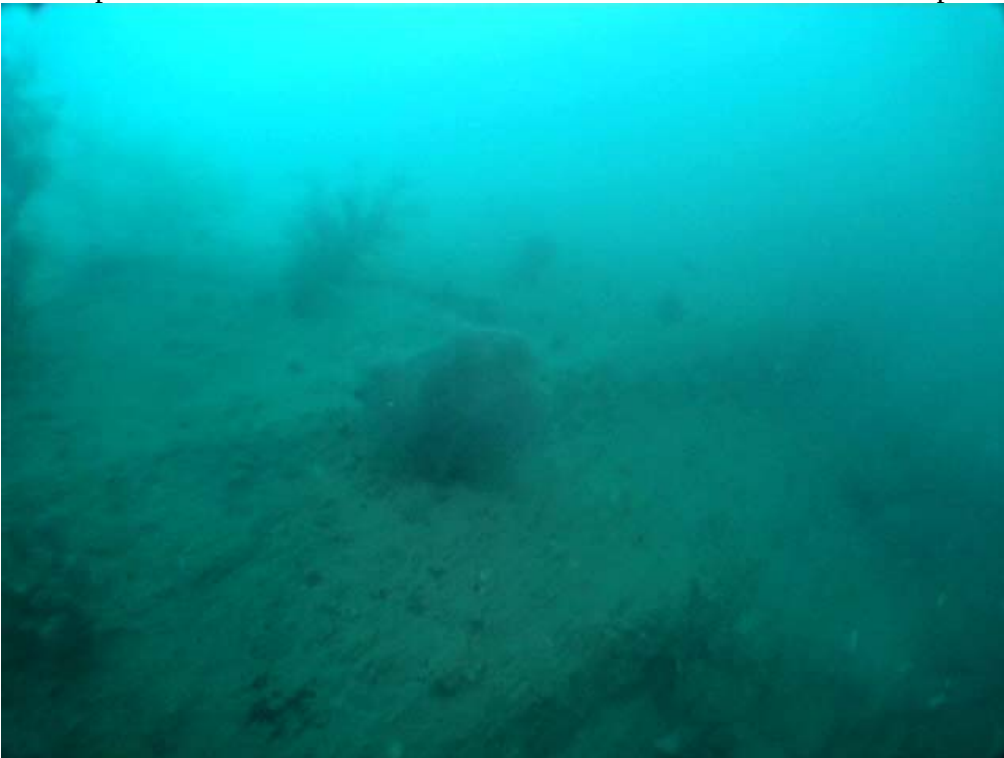
The raised shape on the hull where it covers the Starboard outer propeller shaft stern tube, just prior to the shaft exiting at the gland, can just be seen center of image running left to right. The hull is now *almost* completely back to normal shape.

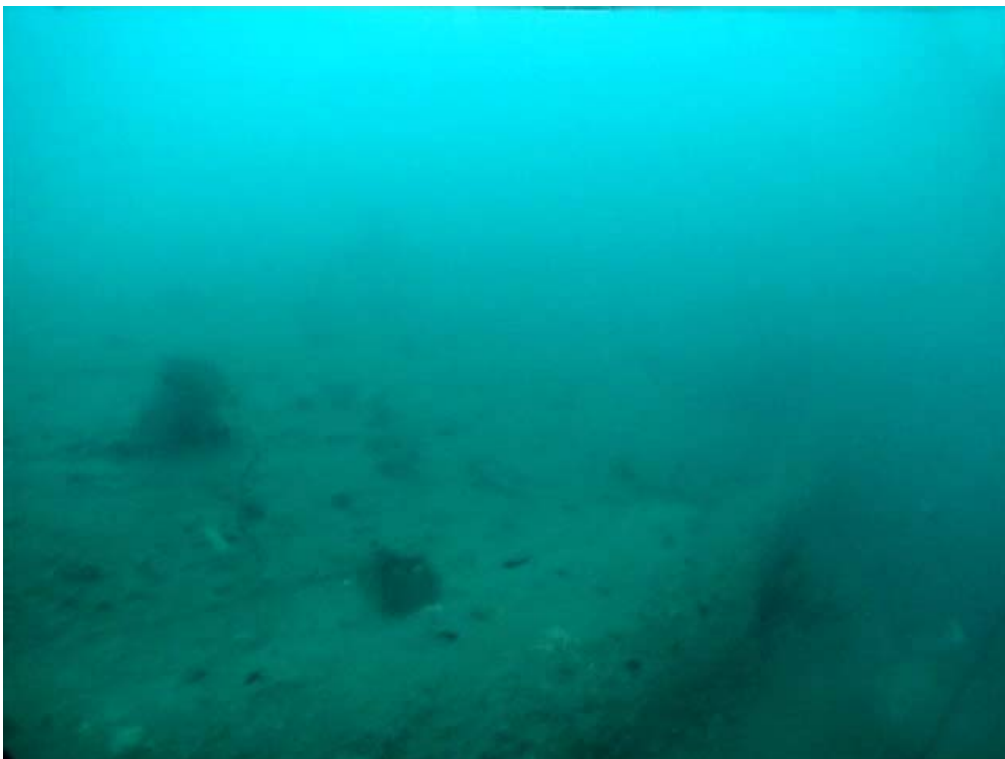
Outer prop shaft can just be seen exiting hull at the stern tube gland lower right. Although not visible in image, the Starboard hull (lower-lower right) is back to 'normal' shape now.
